PERATION

GREENHOUSE

SCIENTIFIC DIRECTOR'S REPORT

ANNEX 3.2 U. S. NAVY STRUCTURES

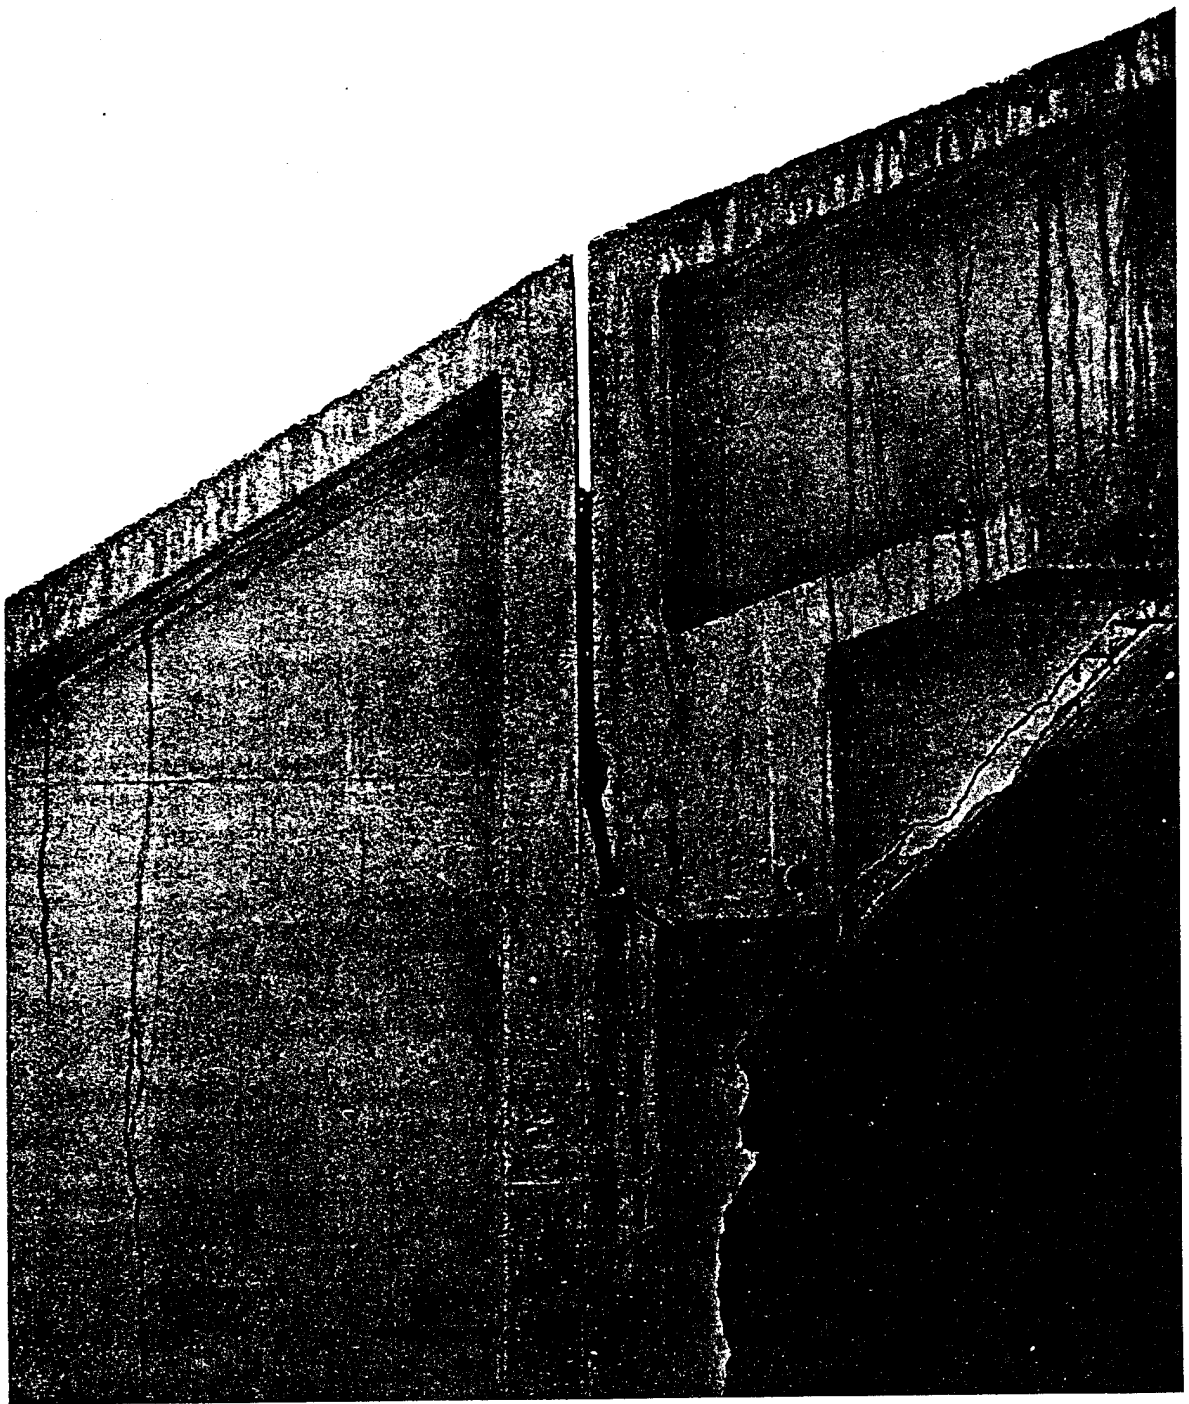
Fig. L.279 Detail View of Front Panel on Right End, Structure 3.2.4a. One-inch vertical opening shows general movement of structure away from blast.

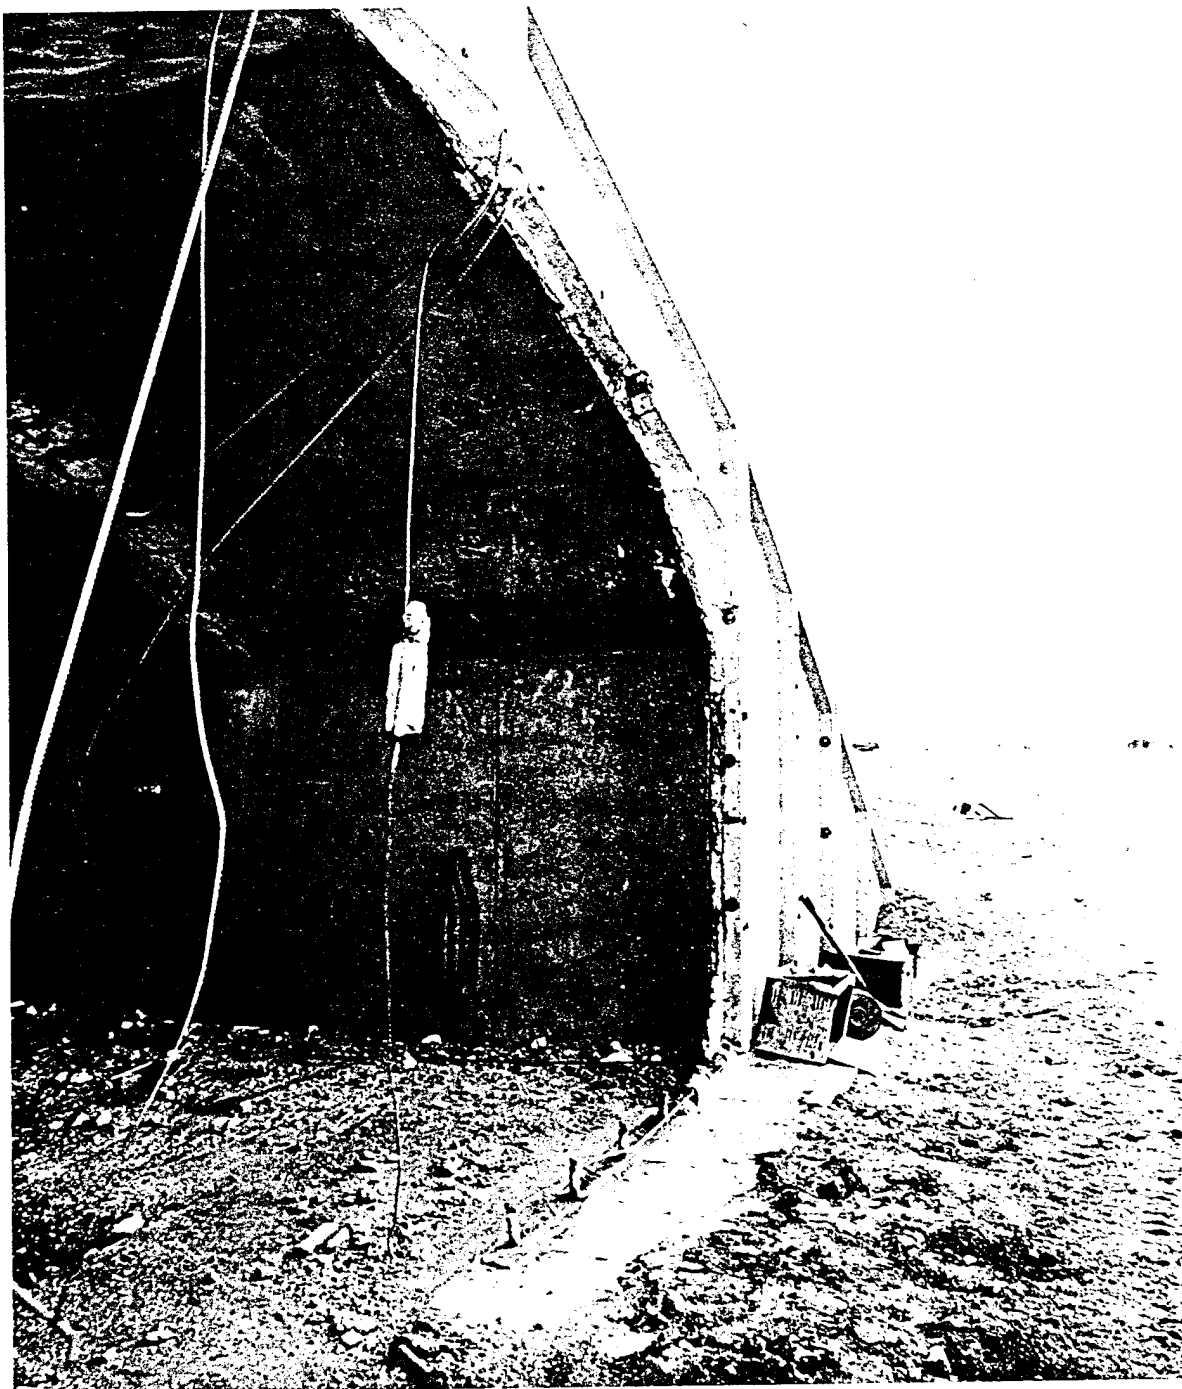
Fig. L.280 Close-up View of Rear Portion of Right End, Structure 3.2.4a. The base rib of the rear end panel was completely gone, but anchor bolts were not damaged. Bolt sleeves remained on bolts.

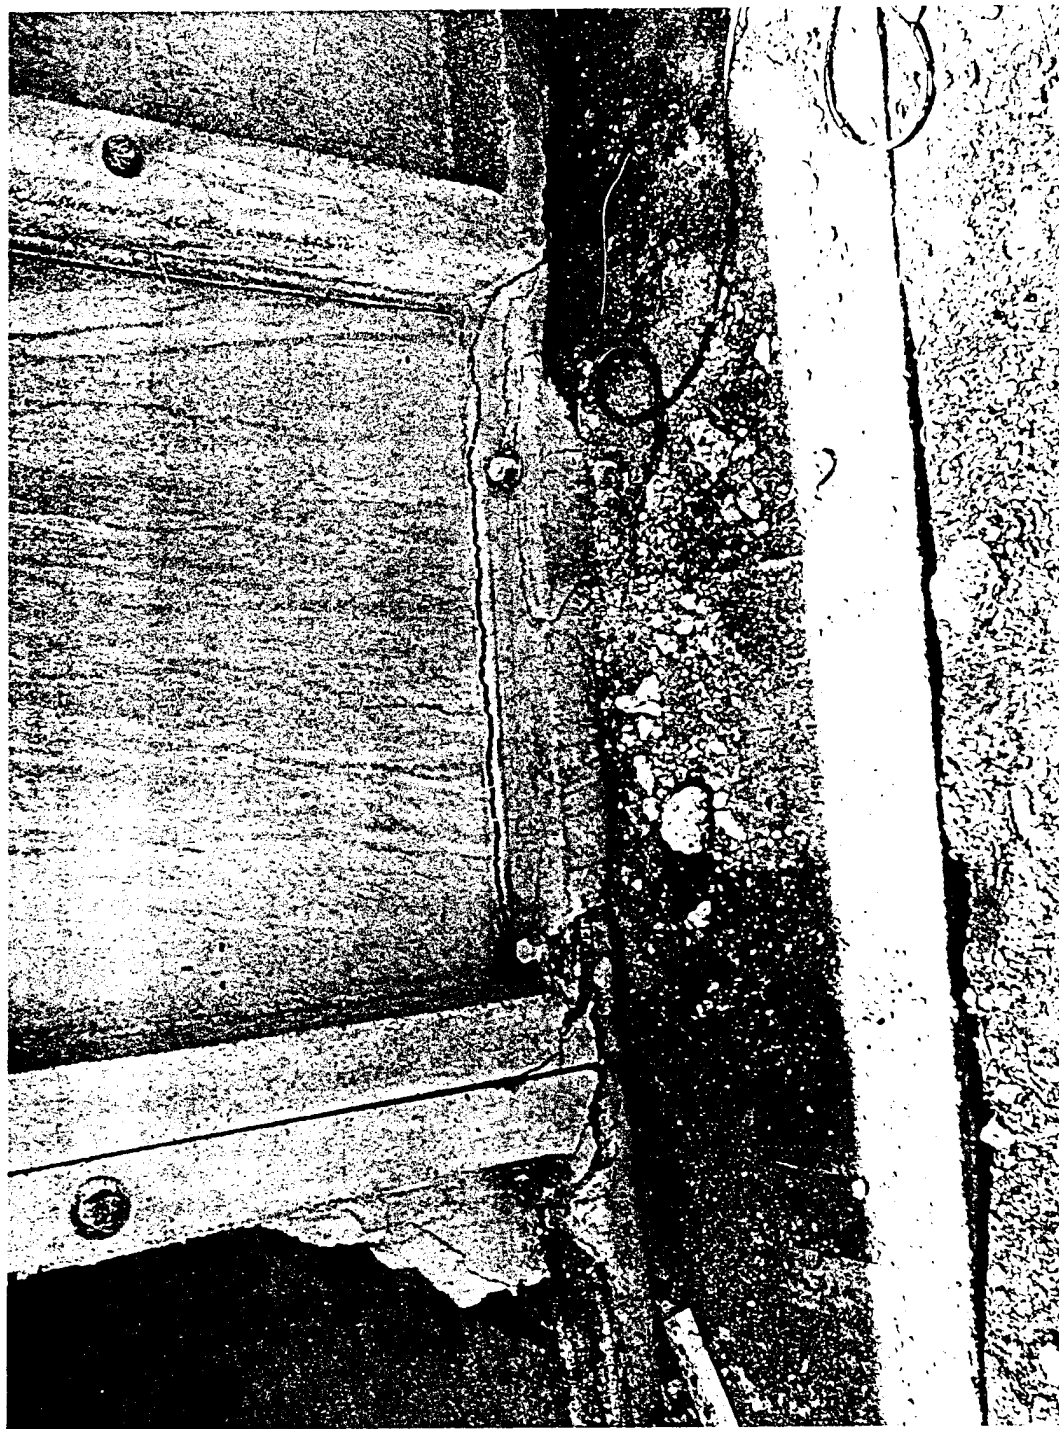
Fig. L. 281 Crack along Base Rib of Rear Wing Wall, Structure 3.2.4a. This panel was subjected to shear forces (toward the right in this photograph) as the main structure deflected under blast loading.

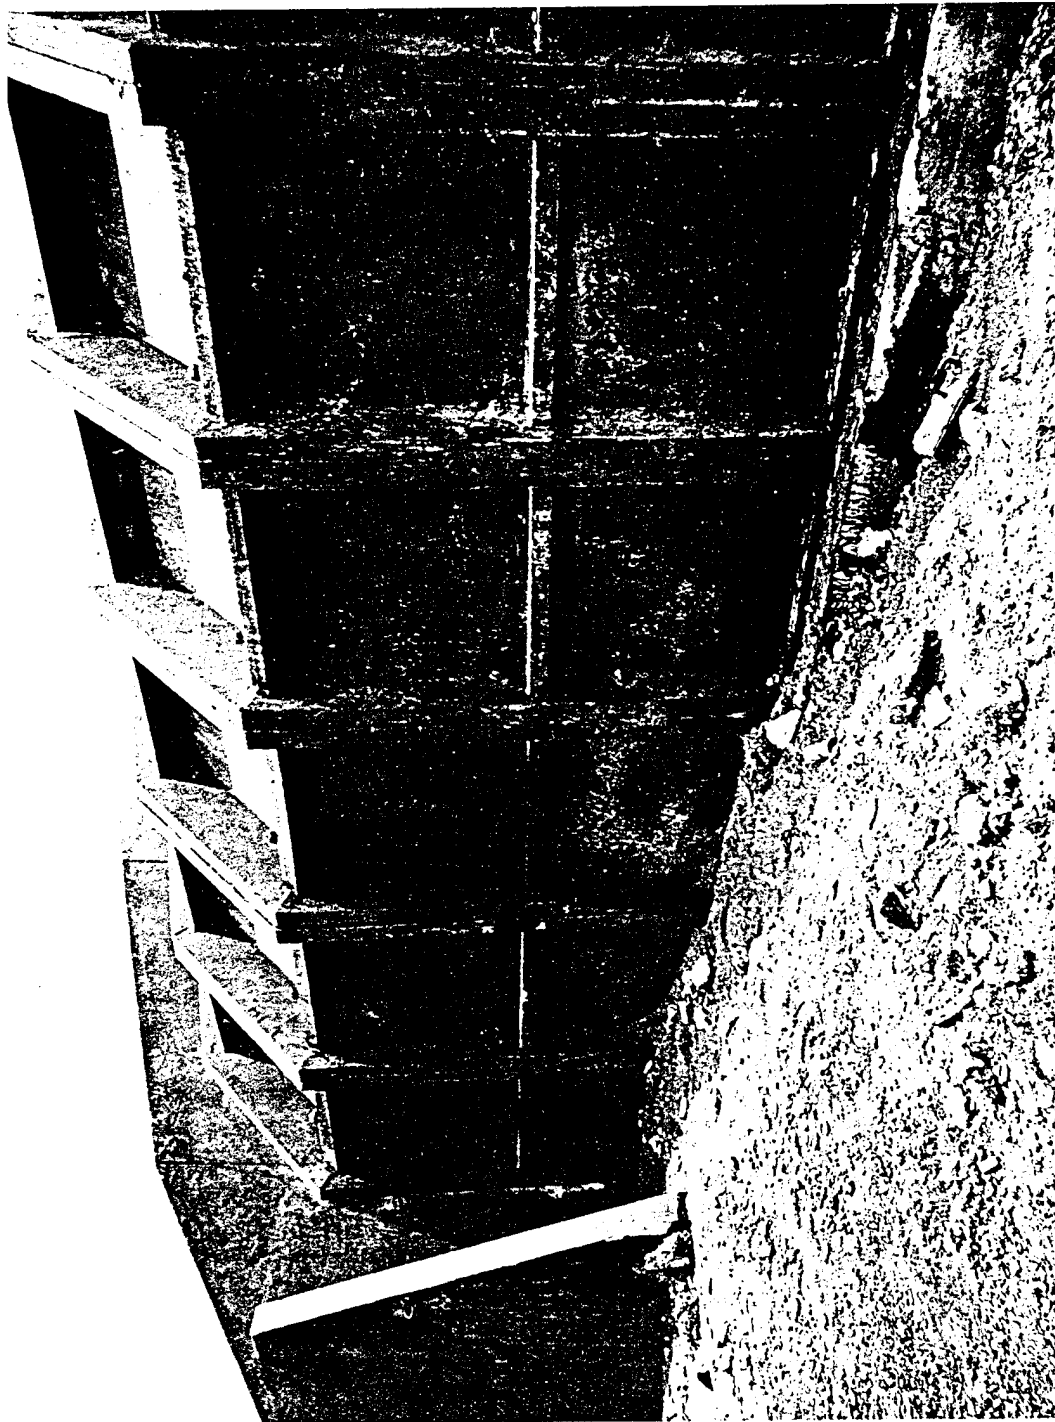
Fig. L. 283 General View along Rear Wall after Earth Cover Was Washed Off, Structure 3.2.4a. No visible damage to any extent.

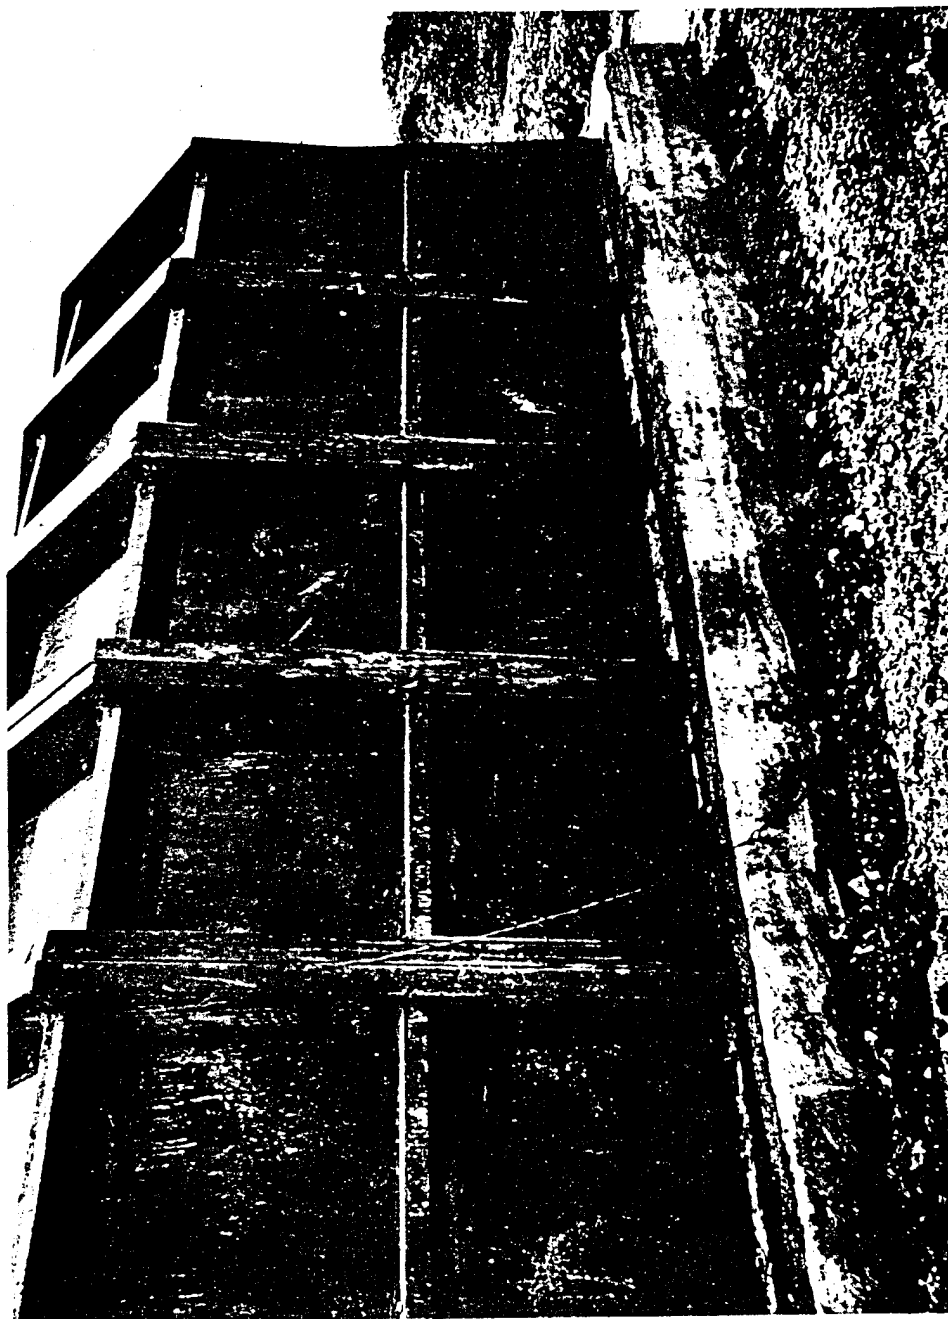
Fig. L.285 Left Half of Rear Wall after Removal of Earth Cover, Structure 3.2.4a. No damage.

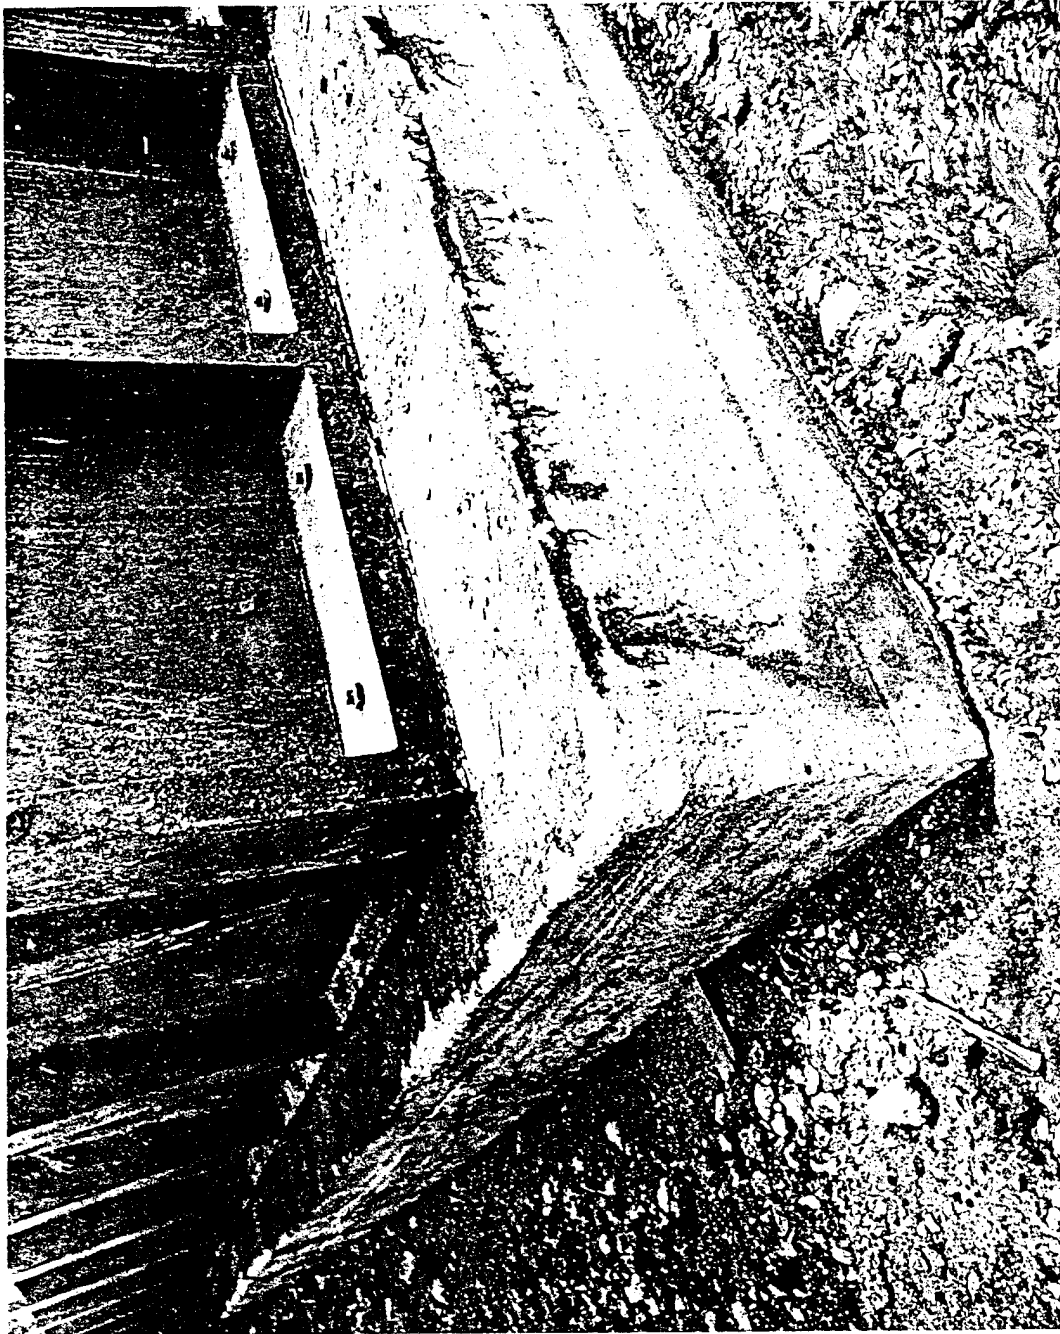
Fig. L. 286 Detail View of Foundation at Left Rear Corner, Structure 3.2.4a. Small crack is barely visible in footing. This was the only crack found in the foundation of this structure.

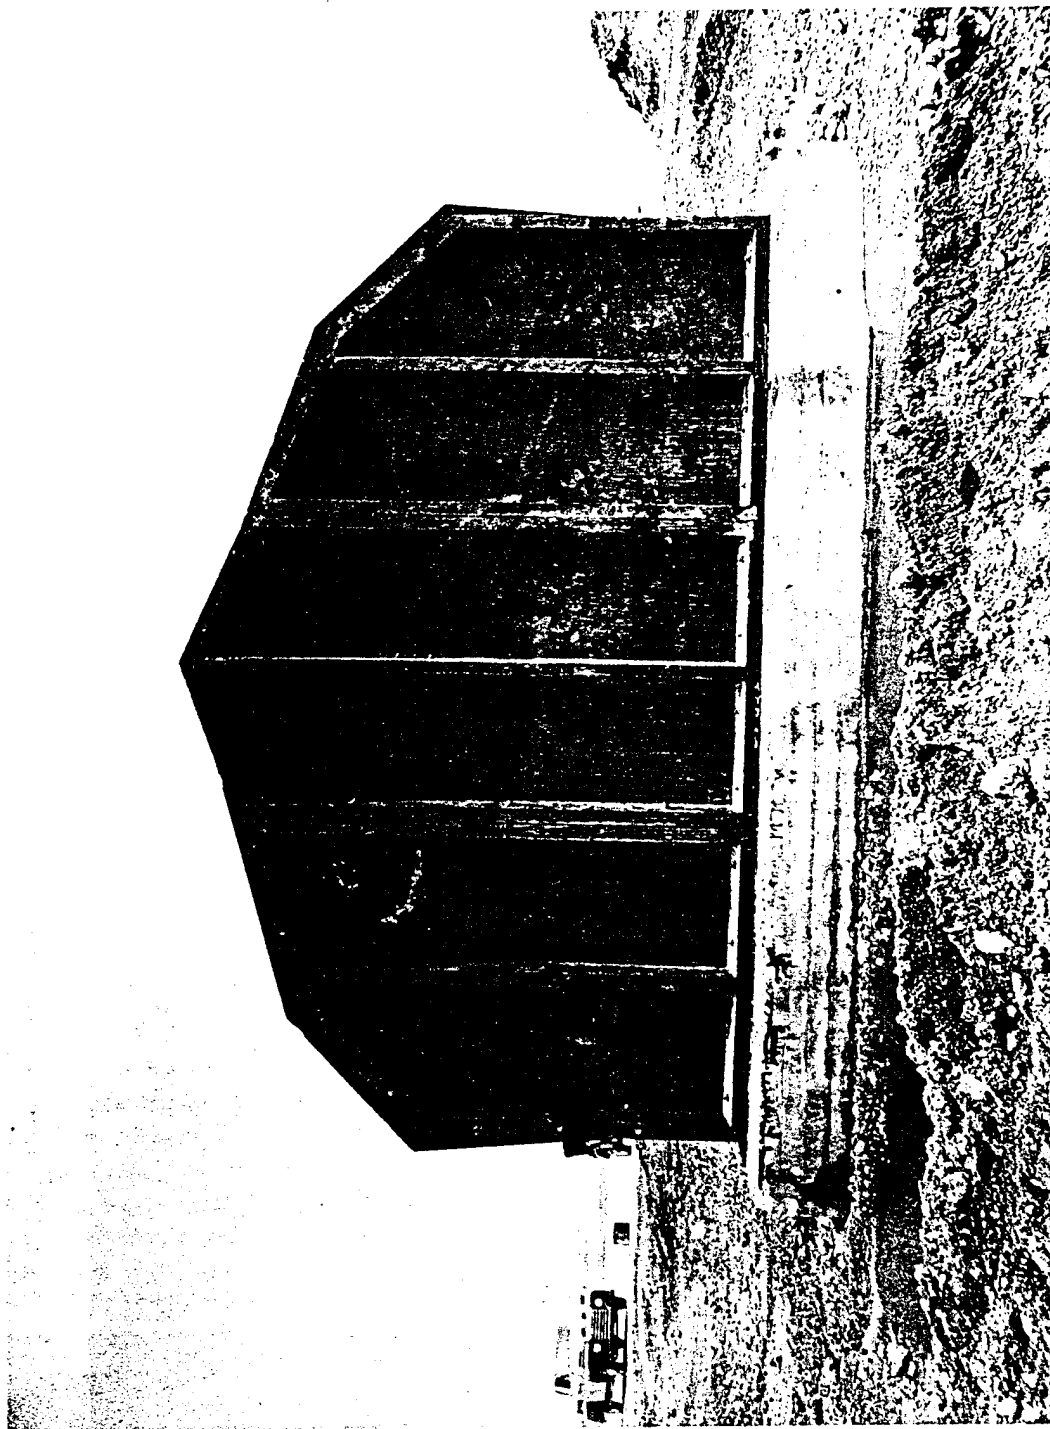
Fig. L. 287 General View of Left End Wall after Removal of Earth Cover, Structure 3.2.4a. The two cracked sections in the panel in the left of the photograph were caused by debris that was hurled into the structure.

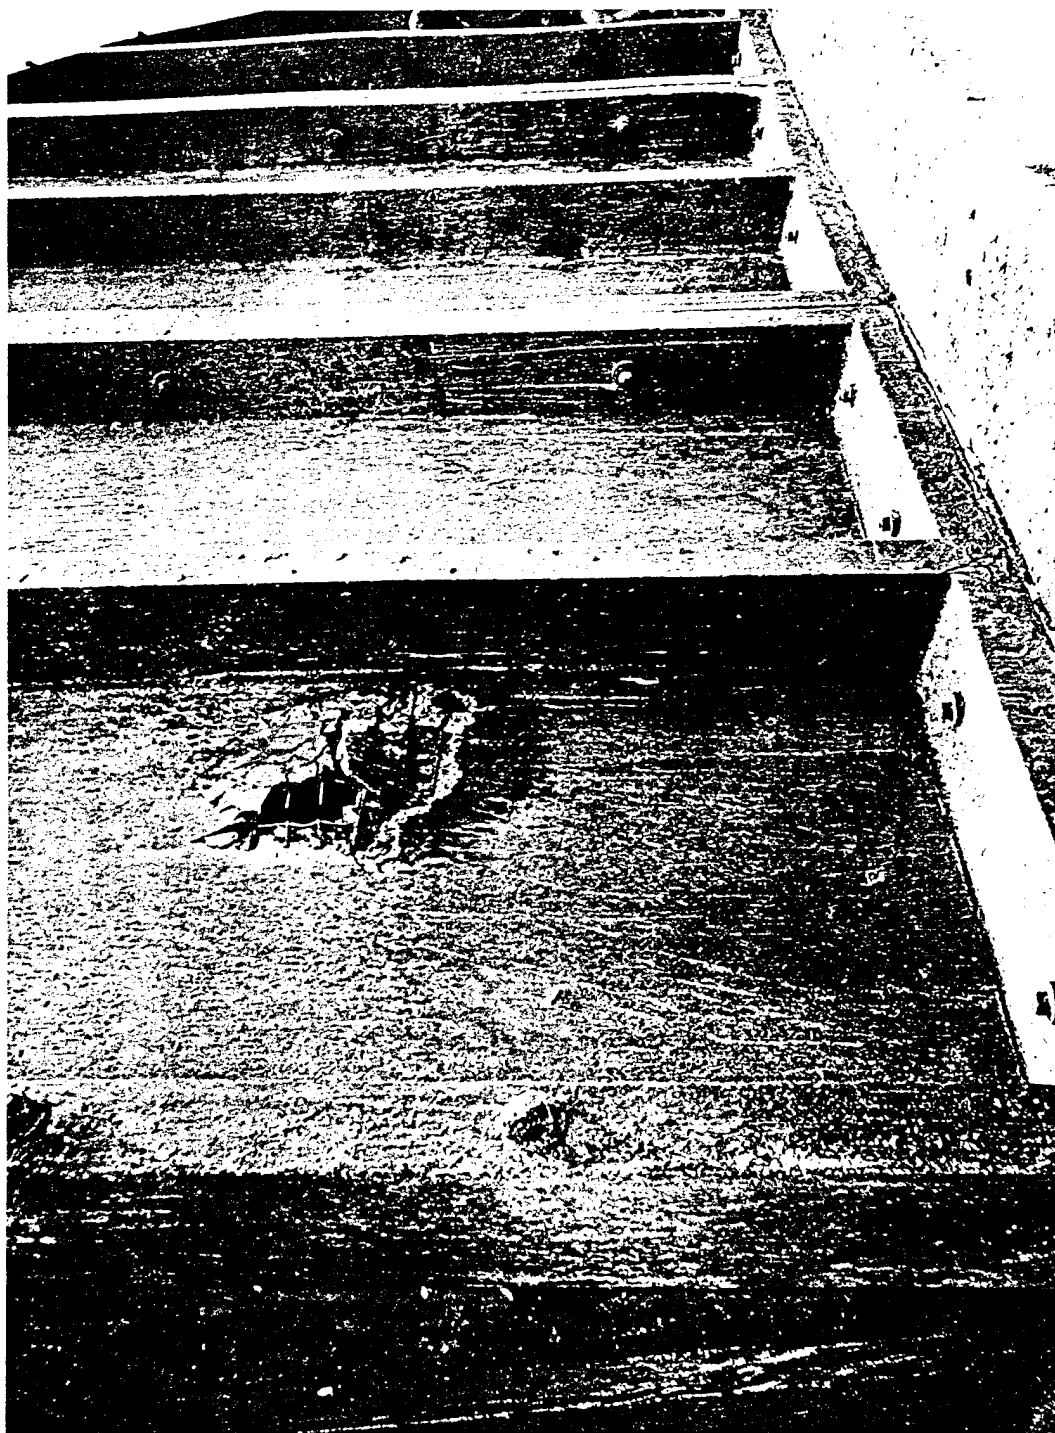
Fig. L. 288 Close-up View of Hole in Rear Wall Caused by Door Panel Hitting It with Great Force, Structure 3. 2. 4a

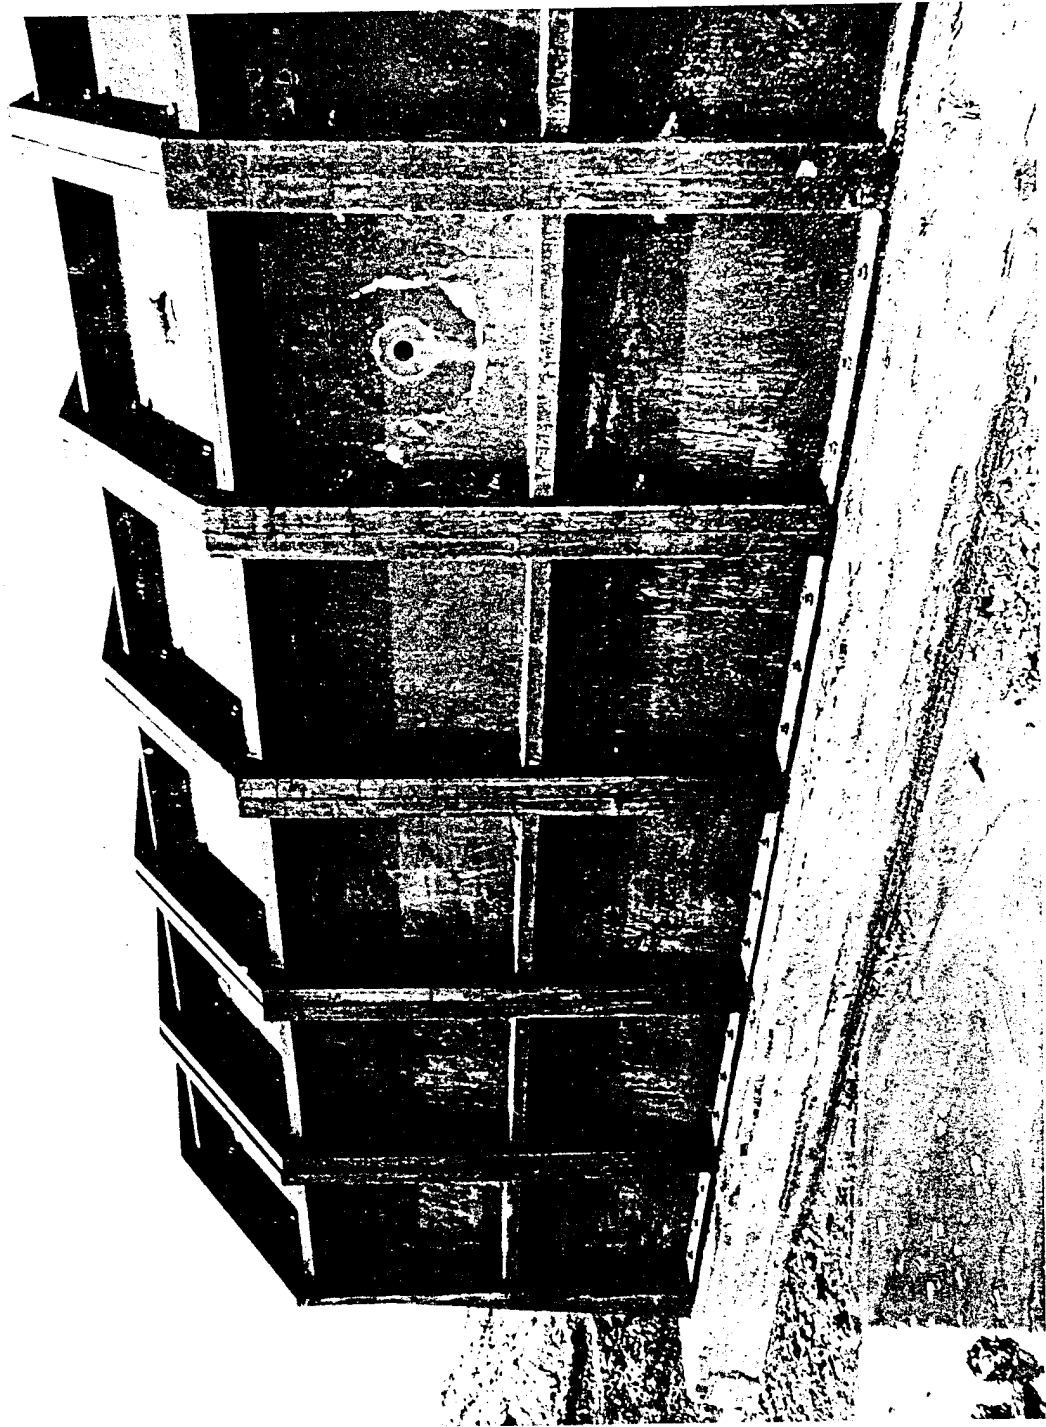
Fig. L. 289 General View of Left Half of Front Face after Removal of Earth Cover, Structure 3. 2. 4a. Small holes show where pressure gauges had been installed.

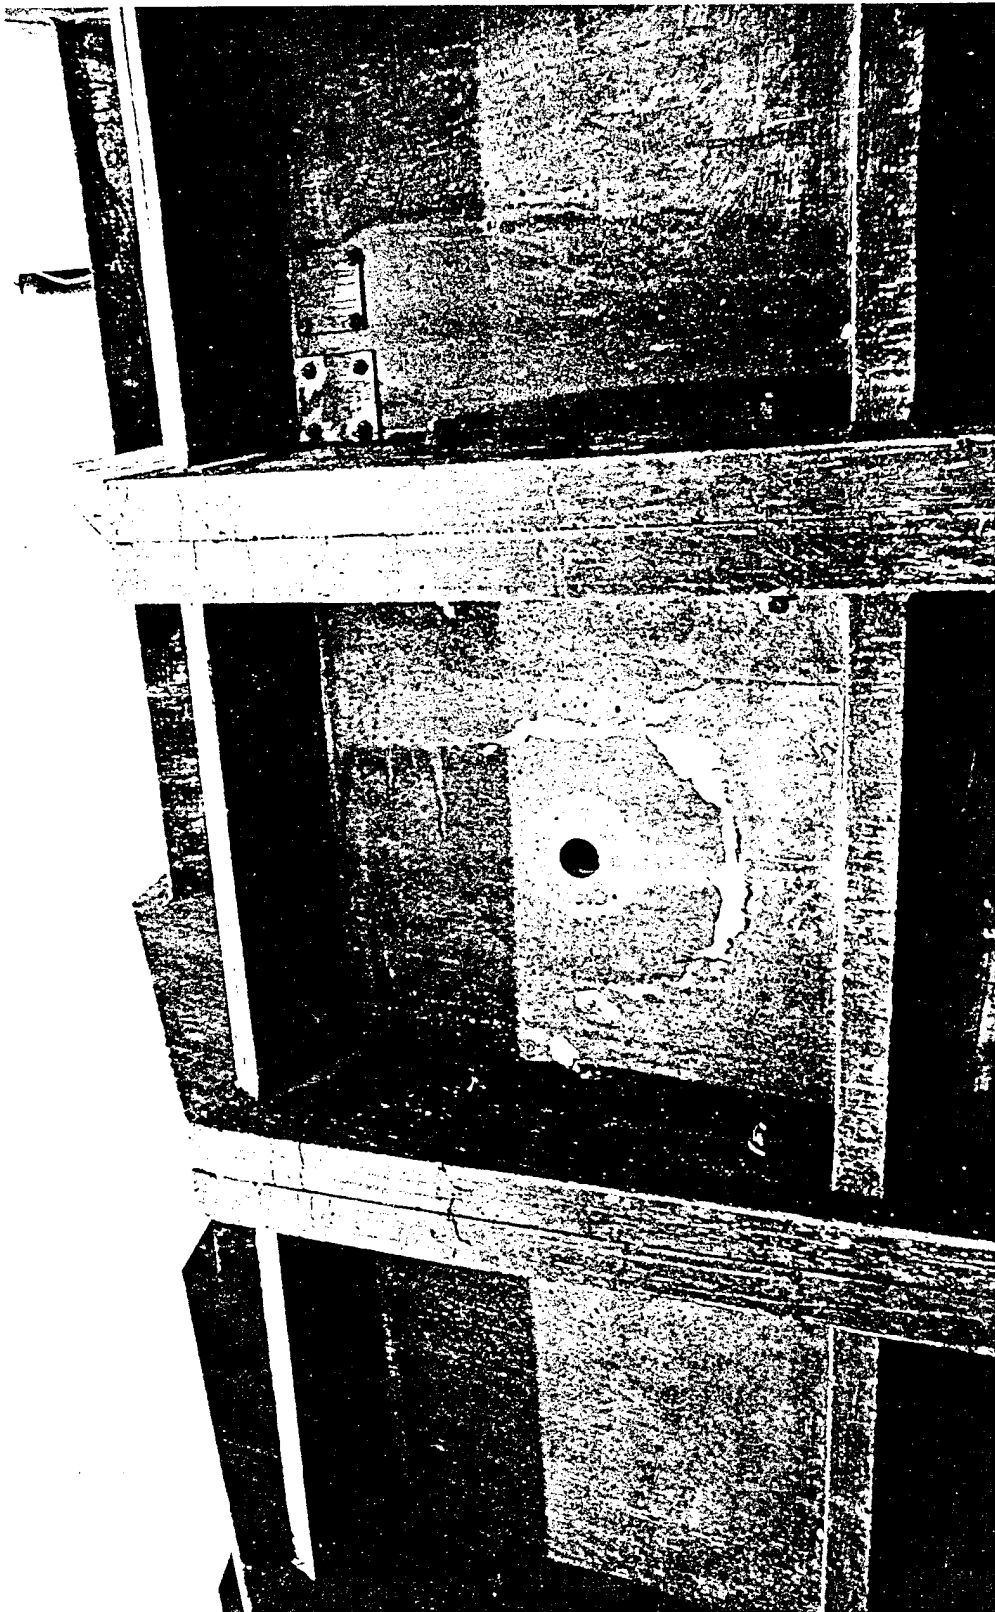
Fig. L.290 Close-up View of Center Portion of Front Wall, Structure 3.2.4a. Tension cracks are visible in the heavy reinforcing ribs near the haunch.

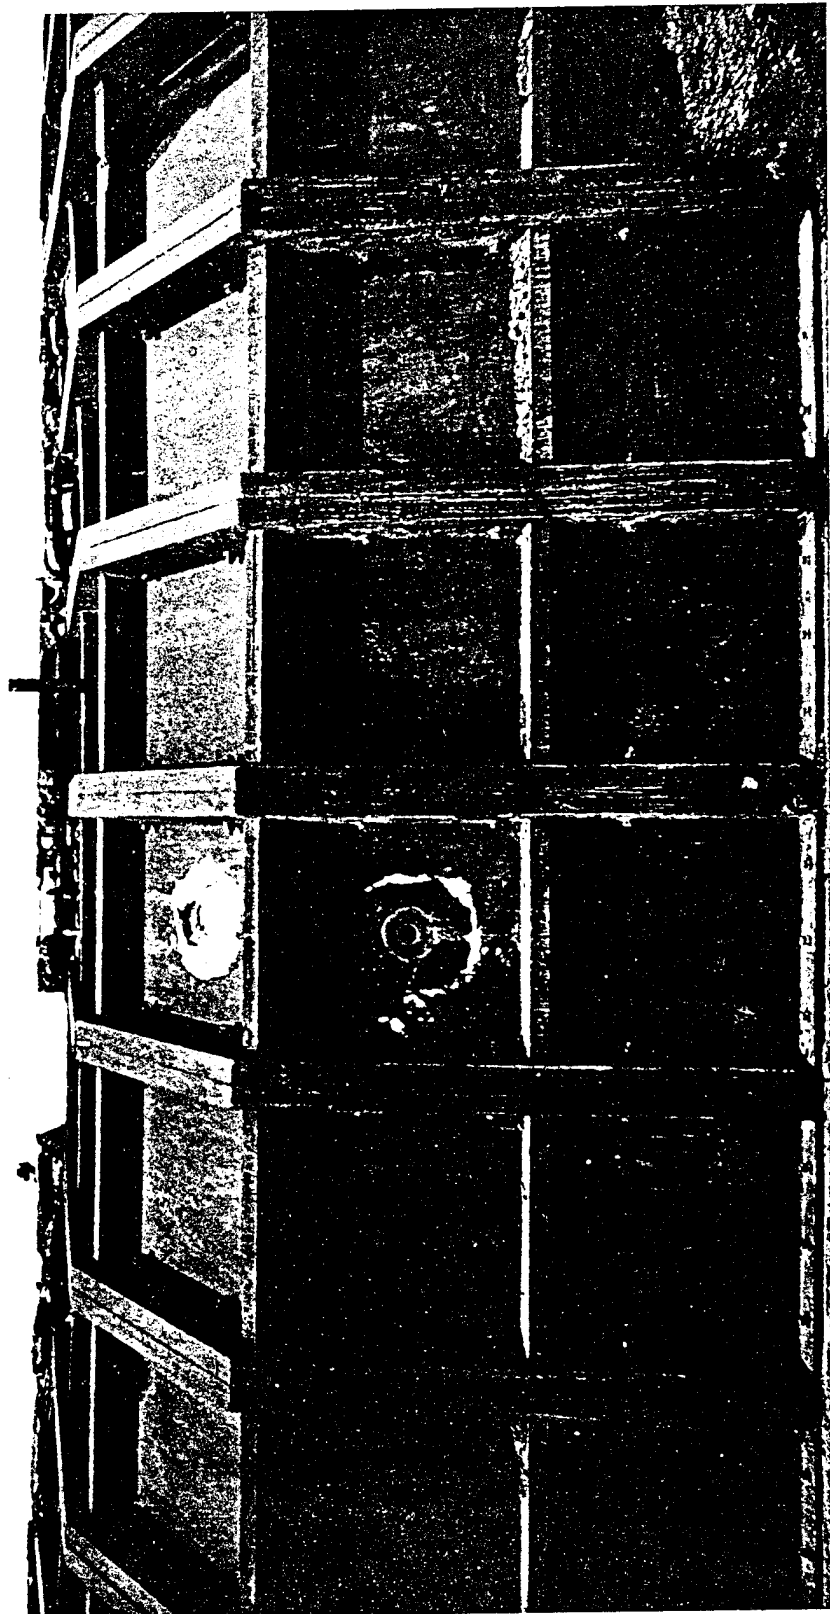
Fig. L. 291 General View of Roof Portion of Front-wall Panels, Structure 3. 2. 4a. Damage to crown joint connection can be clearly seen. Note the vertical dishing of the roof portion of the panels.

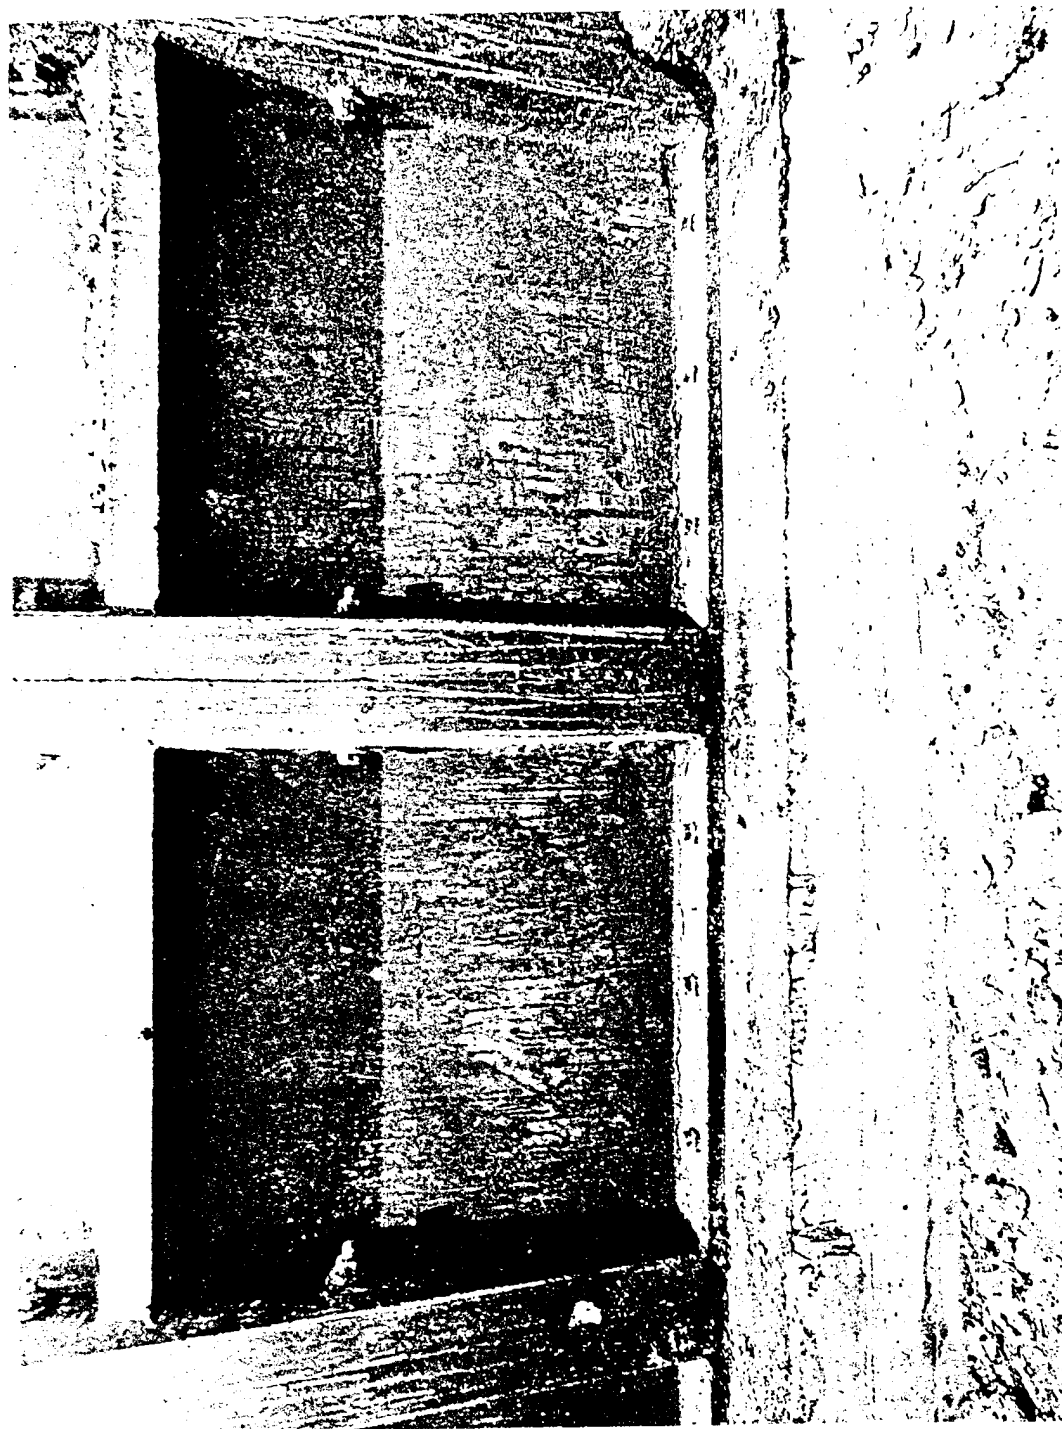
Fig. L. 293 Detail View of Base Ribs of Front-wall Panels, Structure 3. 2. 4a. Slight cracking in ribs can be seen.

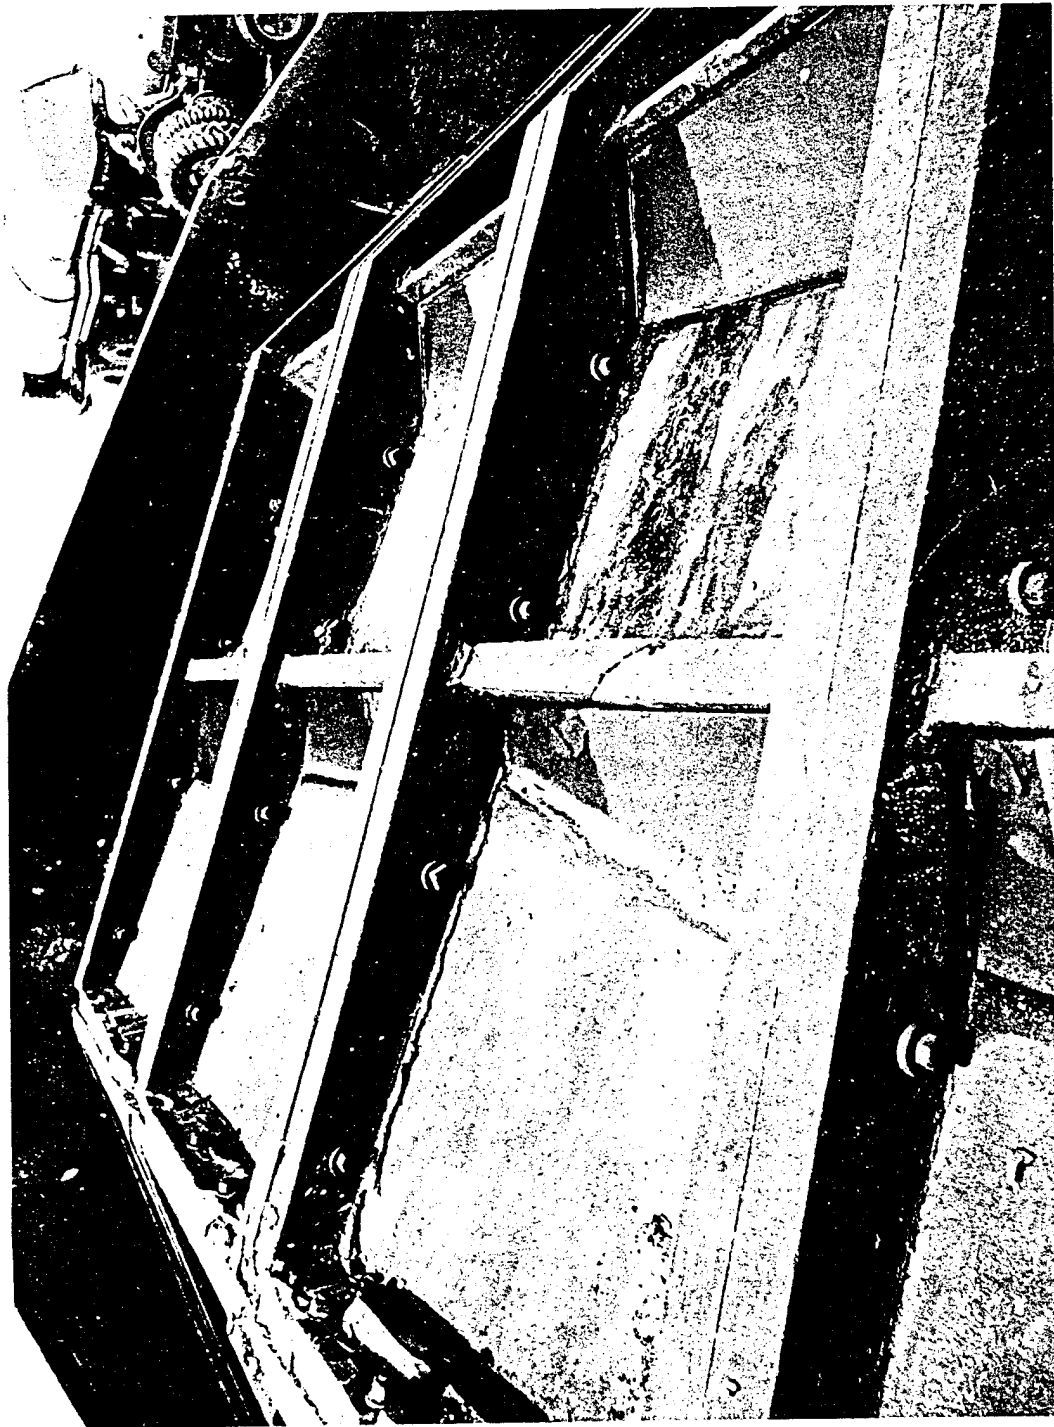
Fig. L. 295 Detail View of Separation Between Rib and Diaphragm Section, Structure 3.2.4a. Separation is the greatest nearest to the crown.

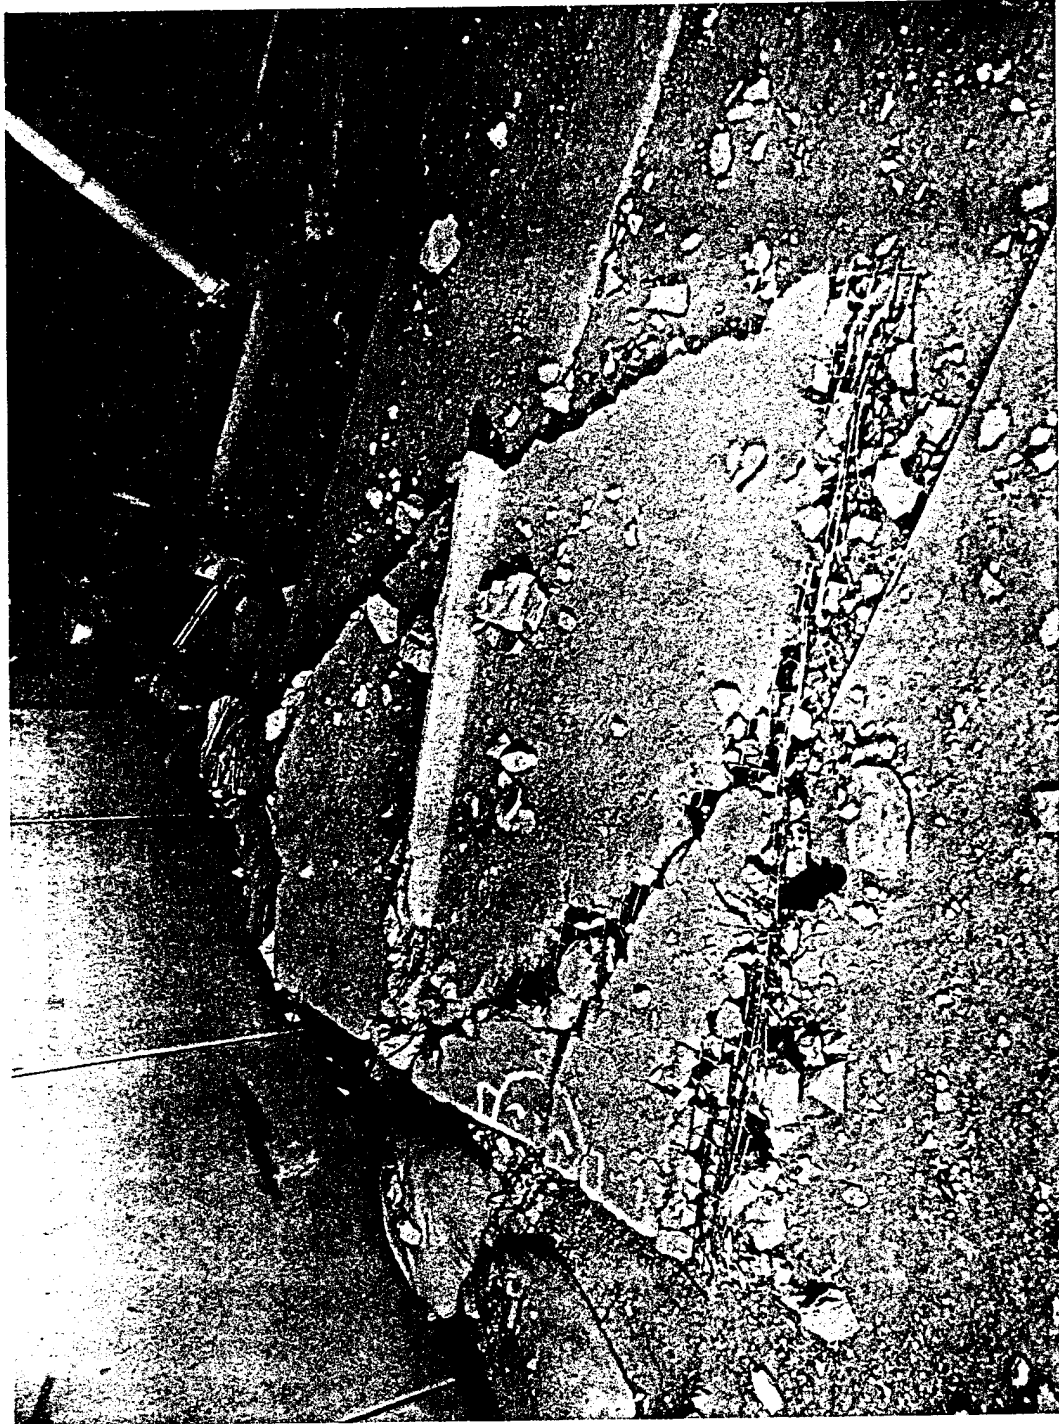
Fig. 'L. 312 Interior View of Front-wall Panels, Structure 3.2.4a. Note section of end-wall panel lying on third-floor panel. See next photograph for detail view.

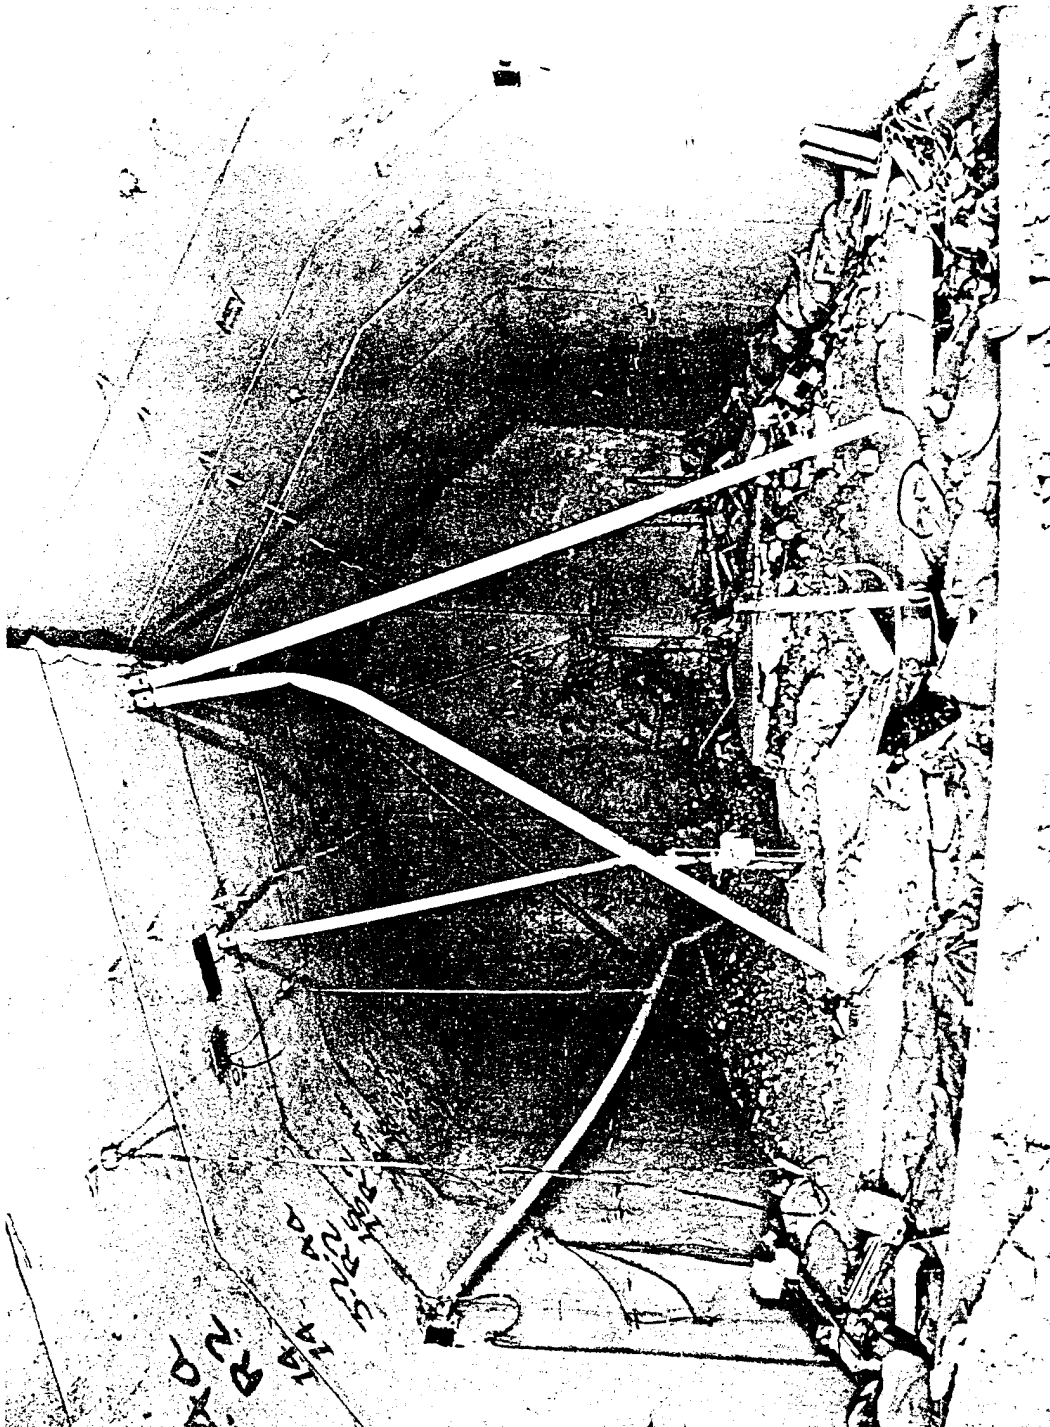
Fig. L. 313 Upper Half of End Panel That Was Adjacent to Front Wall, Structure 3. 2. 4a. For general position of this piece, see preceding photograph.
